**Flood Control Project Maintenance
Levee Inspections**

Fall 2009 Levee Maintenance Deficiency Summary Report

San Joaquin River Basin

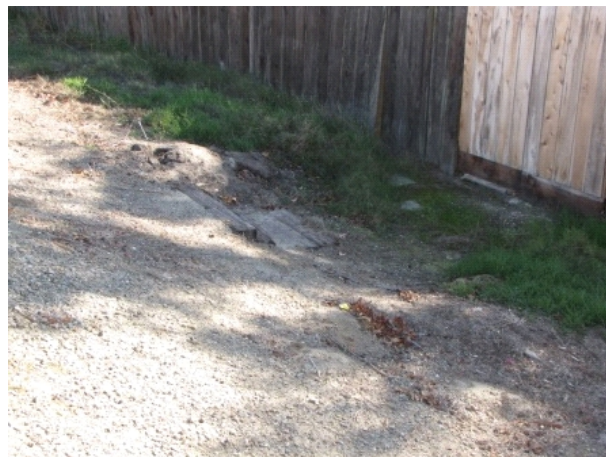
Levee Mile Report Line	65
Start Levee Mile	1.71
End Levee Mile	1.71
Location	Land Side
Category	Earthen Levee
Item	Encroachments

View of steps dug into the landward slope looking upstream.

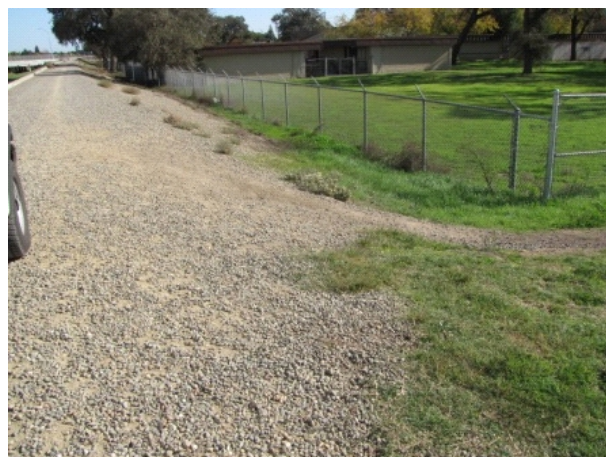
Levee Mile Report Line	67
Start Levee Mile	1.86
End Levee Mile	1.86
Location	Land Side
Category	Earthen Levee
Item	Encroachments

View of steps dug into the landward slope looking upstream.

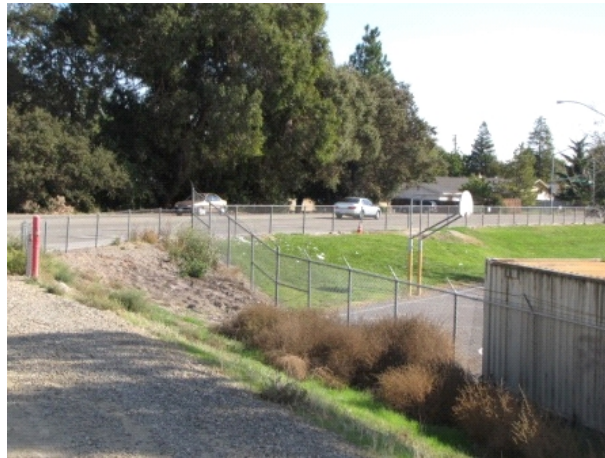
View of tumbleweeds along the landward toe.

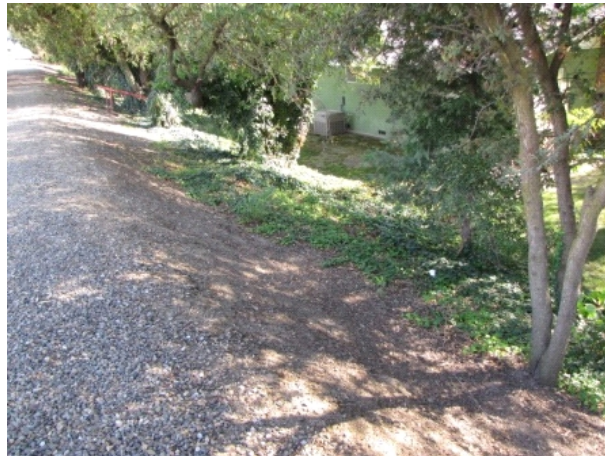
Levee Mile Report Line	69
Start Levee Mile	2.04
End Levee Mile	2.07
Location	Land Side
Category	Earthen Levee
Item	Encroachments

View of landscaping along the landward slope looking upstream. County crews have greatly reduced the amount of material and increased visibility and access.

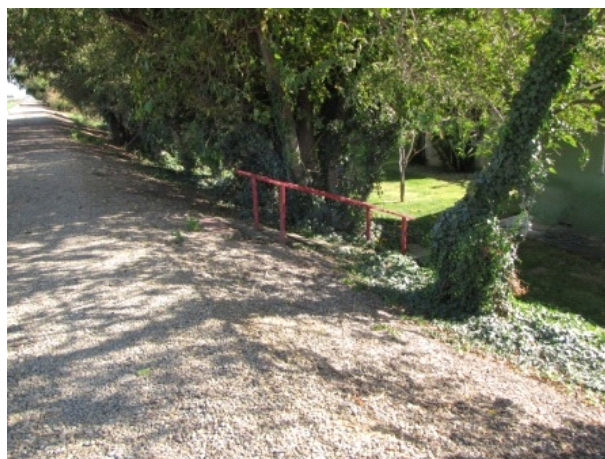
Levee Mile Report Line	71
Start Levee Mile	2.06
End Levee Mile	2.06
Location	Land Side
Category	Earthen Levee
Item	Encroachments

View of steps dug into the landward slope looking upstream.

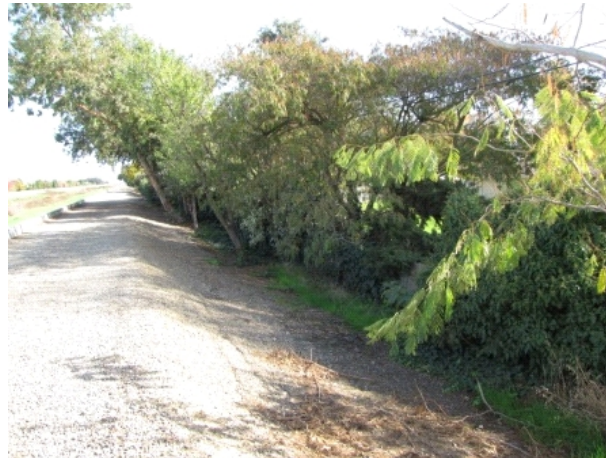
View of a fence with landscaping growing on it at the landward toe looking upstream.

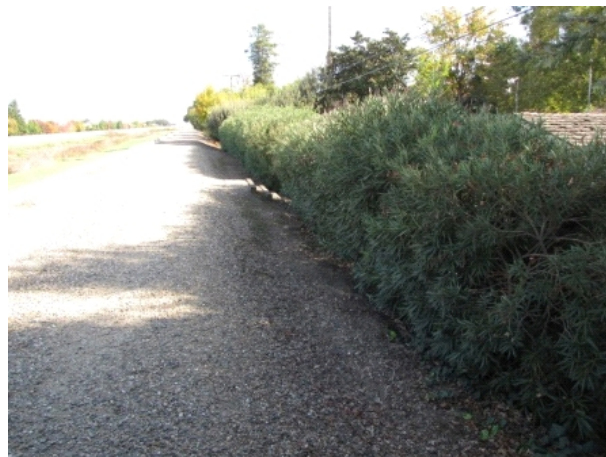
Levee Mile Report Line	73
Start Levee Mile	2.14
End Levee Mile	2.16
Location	Land Side
Category	Earthen Levee
Item	Encroachments

View of landscaping along the landward slope looking upstream.

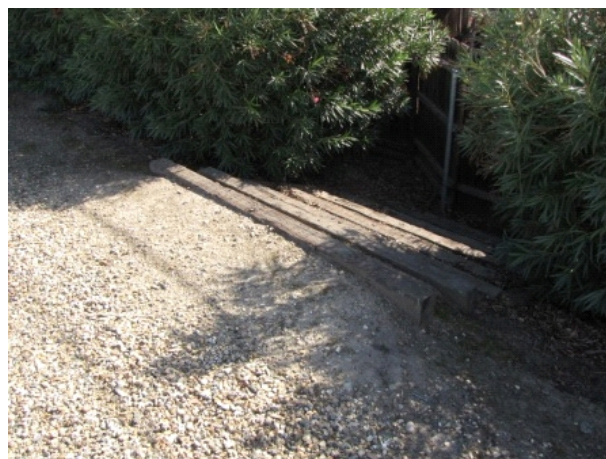
Levee Mile Report Line	74
Start Levee Mile	2.15
End Levee Mile	2.15
Location	Land Side
Category	Earthen Levee
Item	Encroachments

View of steps dug into the landward slope.

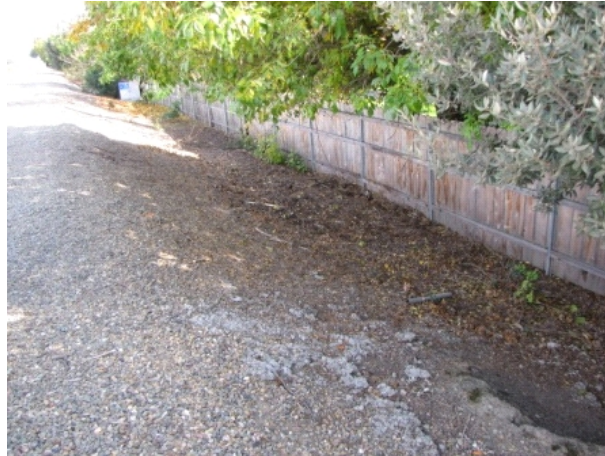
View of a fence along the landward toe looking upstream.

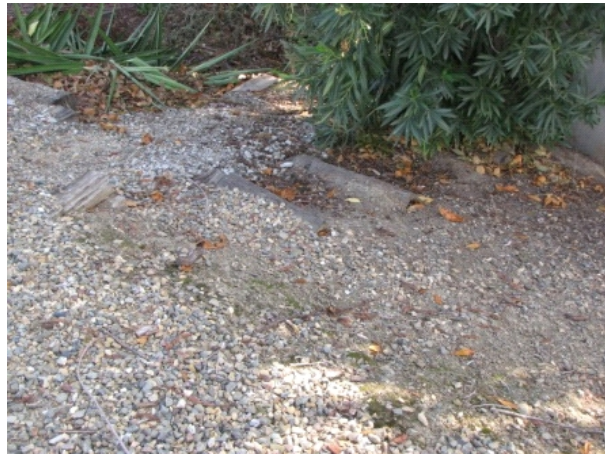
Levee Mile Report Line	76
Start Levee Mile	2.19
End Levee Mile	2.19
Location	Land Side
Category	Earthen Levee
Item	Encroachments

View of steps dug into the landward slope.

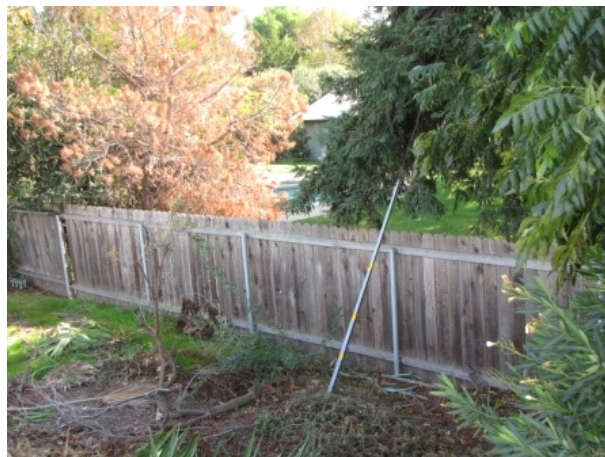
Levee Mile Report Line	77
Start Levee Mile	2.19
End Levee Mile	2.25
Location	Land Side
Category	Earthen Levee
Item	Encroachments

View of a fence along the landward toe.

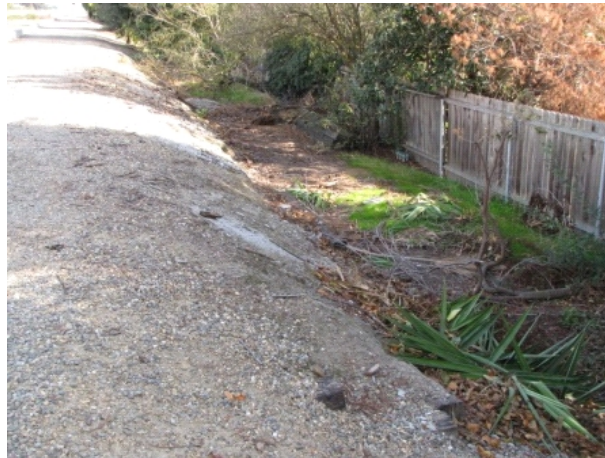
View of prunings on the landward slope and toe looking upstream.

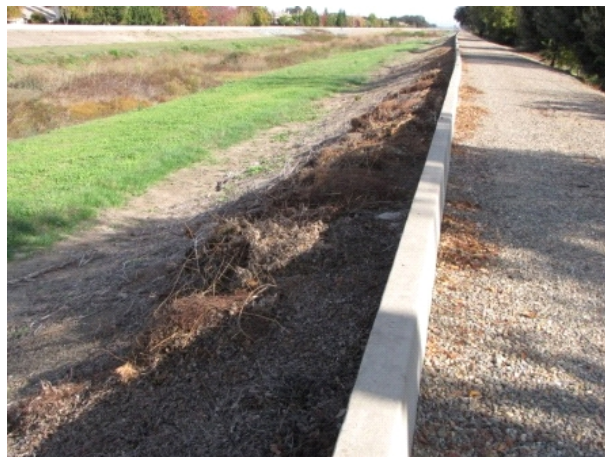
Levee Mile Report Line	79
Start Levee Mile	2.19
End Levee Mile	2.21
Location	Water Side
Category	Earthen Levee
Item	Encroachments

View of prunings on the waterward slope looking upstream.

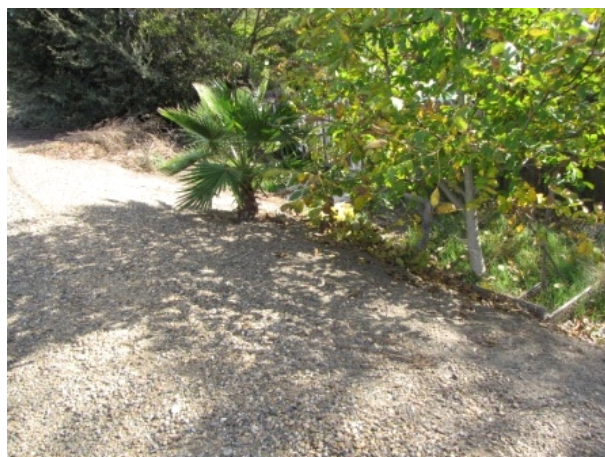
Levee Mile Report Line	80
Start Levee Mile	2.22
End Levee Mile	2.22
Location	Land Side
Category	Earthen Levee
Item	Encroachments

View of landscaping on the landward slope.

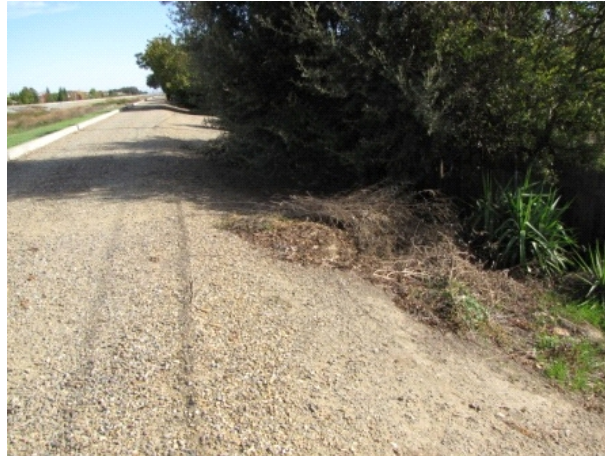
dpesaven_20091124_578.jpg

View of prunings on the landward slope looking upstream.

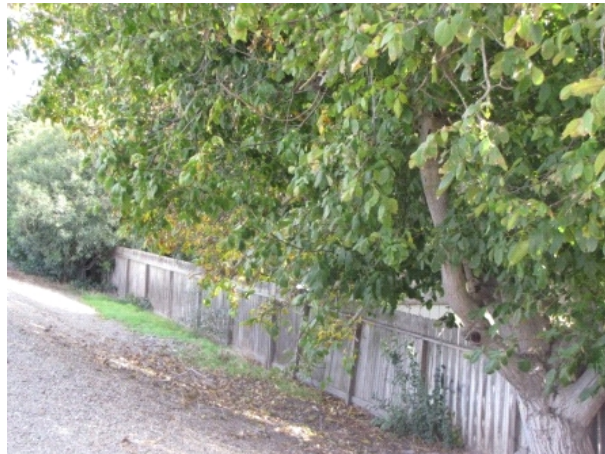
dpesaven_20091124_579.jpg

View of a wood fence at the landward toe.

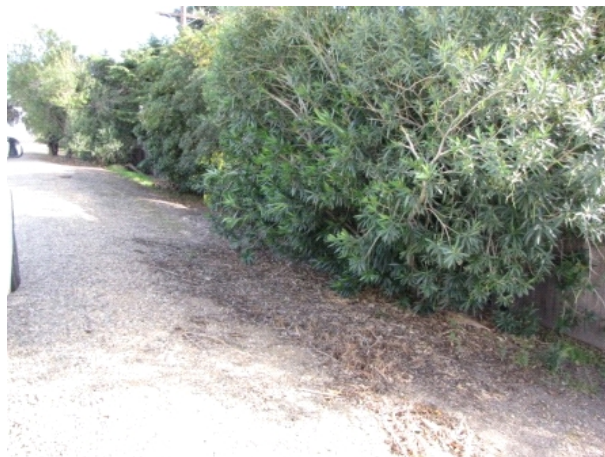
dpesaven_20091124_580.jpg

View of landscaping along the landward slope looking upstream.

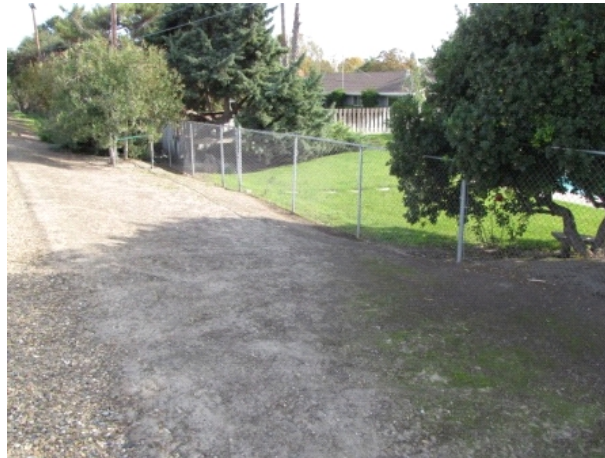
dpesaven_20091124_582.jpg

View of a fence on the landward slope looking upstream.

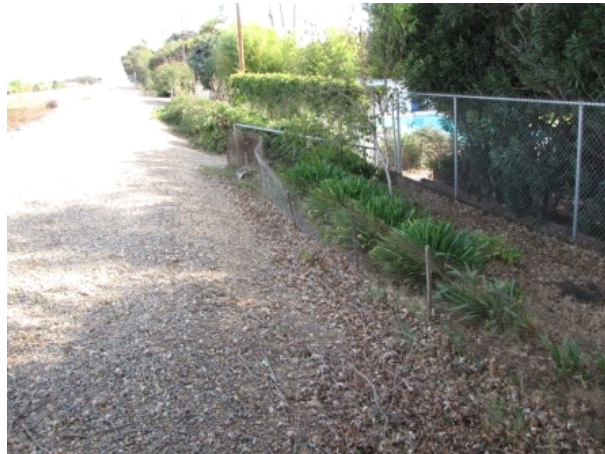
dpesaven_20091124_581.jpg

View of landscaping on the landward slope looking upstream.

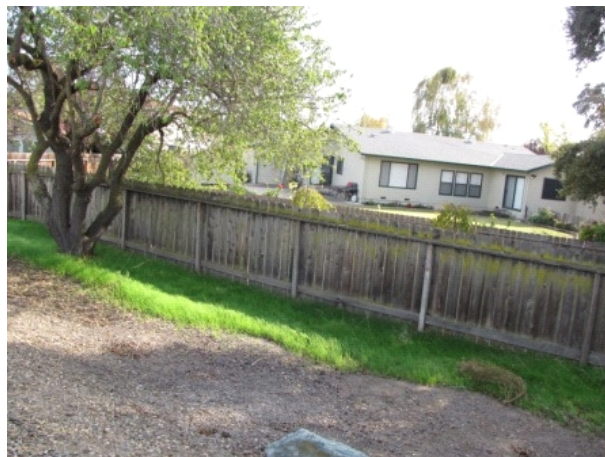
dpesaven_20091124_583.jpg

View of a fence at the landward toe.

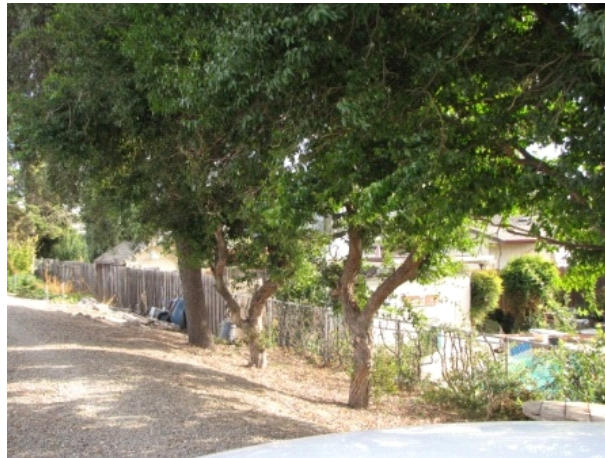
dpesaven_20091124_584.jpg

View of a fence at the landward toe.

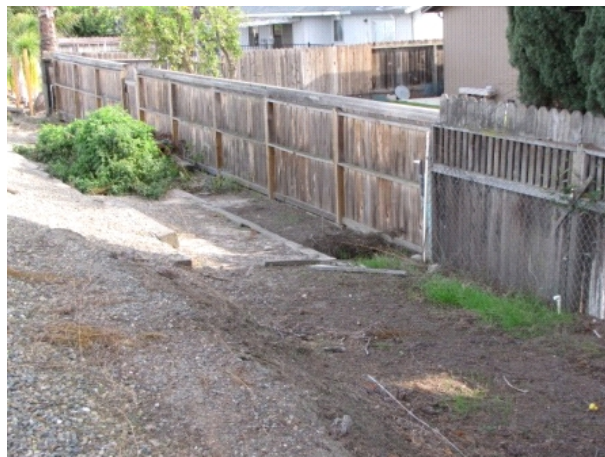
dpesaven_20091124_586.jpg

View of a fence at the landward toe looking upstream.

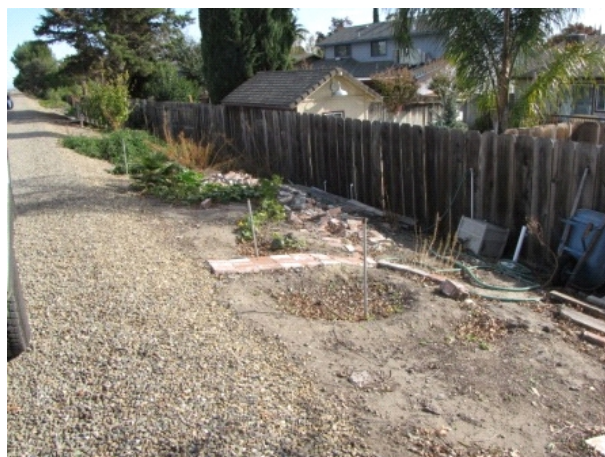
dpesaven_20091124_585.jpg

View of debris and landscaping on the landward slope looking upstream.

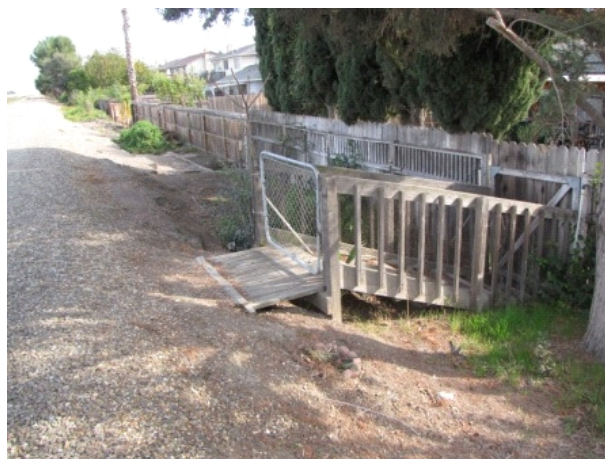
dpesaven_20091124_587.jpg

View of steps dug into the landward slope looking upstream.

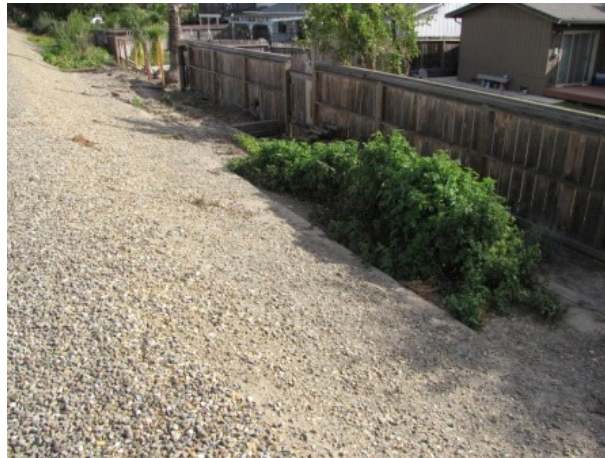
dpesaven_20091124_590.jpg

View of vegetable plants and other material on the landward slope and toe.

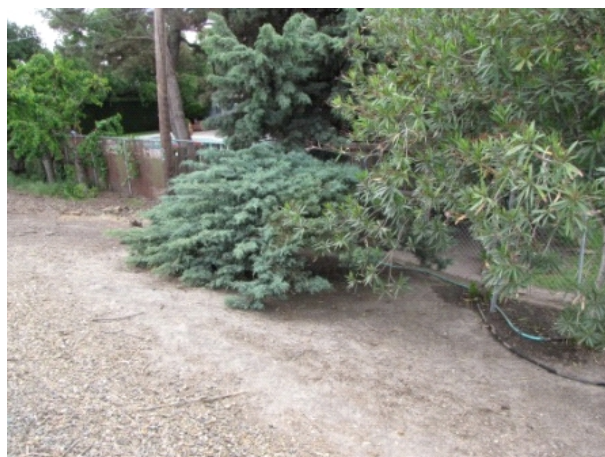
dpesaven_20091022_97.jpg

Landscaping along landward slope of levee blocking visibility and access.

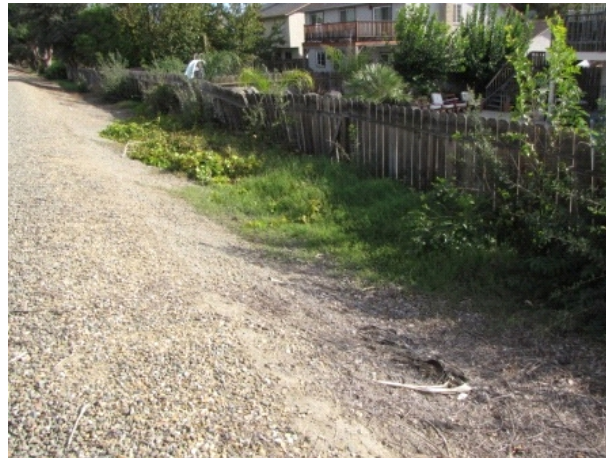
dpesaven_20091124_591.jpg

View of vegetation blocking visibility and access along the landward toe looking upstream.

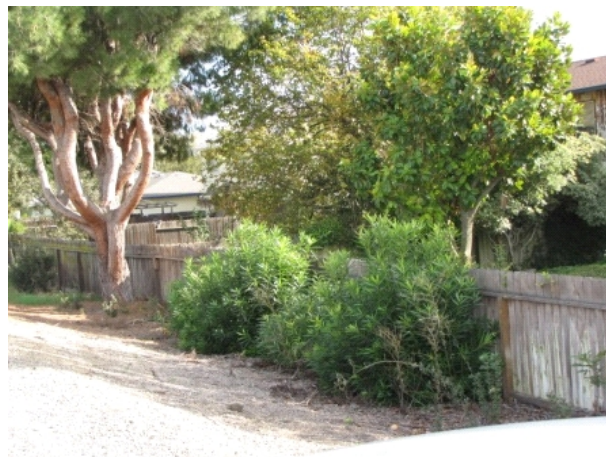
dpesaven_20091124_592.jpg

View of landscaping along the landward toe.

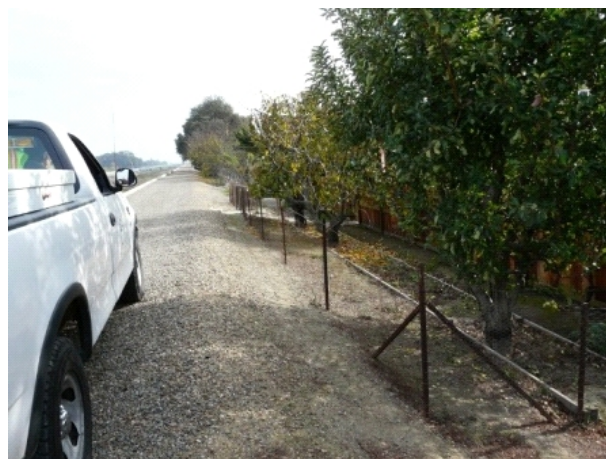
dpesaven_20091022_86.JPG

Fence located to sholder of landside of levee from LM 2.58 to LM 5.61

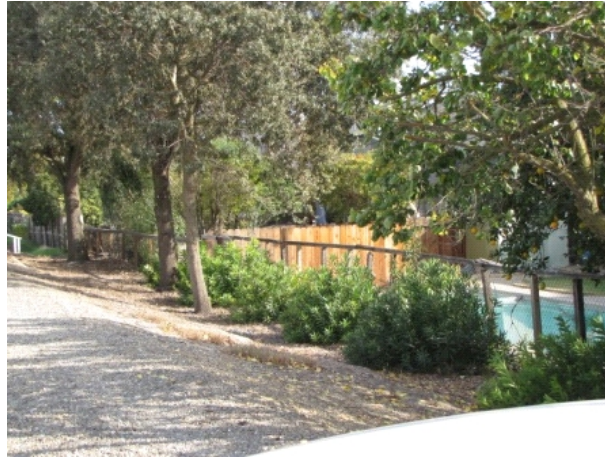
dpesaven_20091124_593.jpg

View of landscaping along the landward slope.

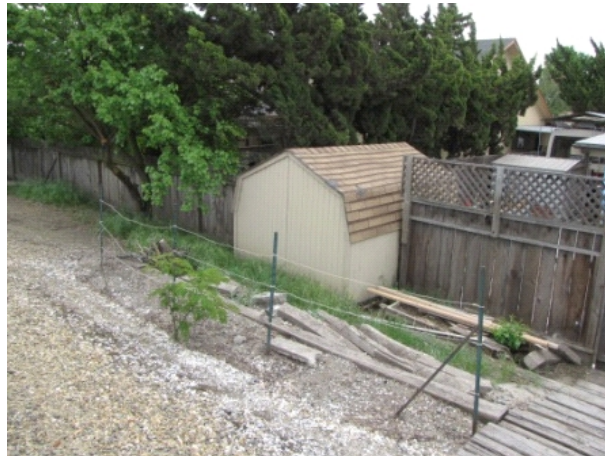
dpesaven_20091022_98.jpg

Landscaping and shed placed on landward levee slope and within 10' of the toe.

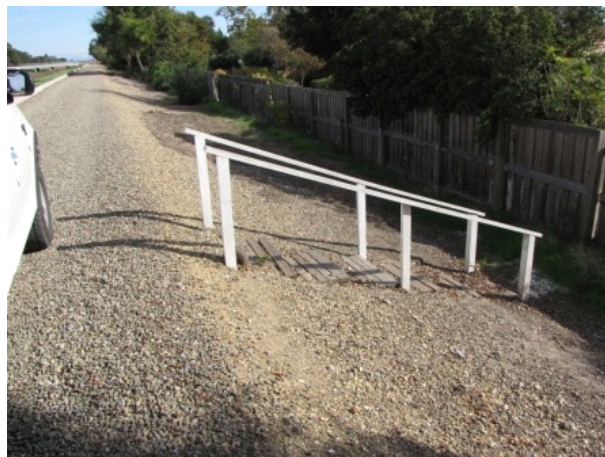
dpesaven_20091124_594.jpg

View of steps dug into the landward slope looking upstream.

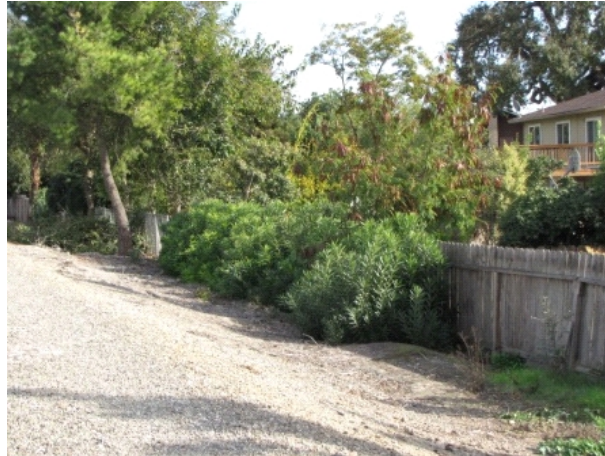
dpesaven_20091124_595.jpg

View of landscaping along the landward toe looking upstream.

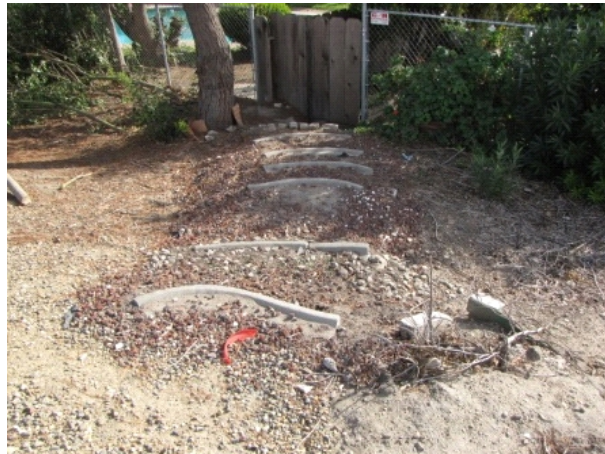
dpesaven_20091124_597.jpg

View of steps dug into the landward slope looking upstream.

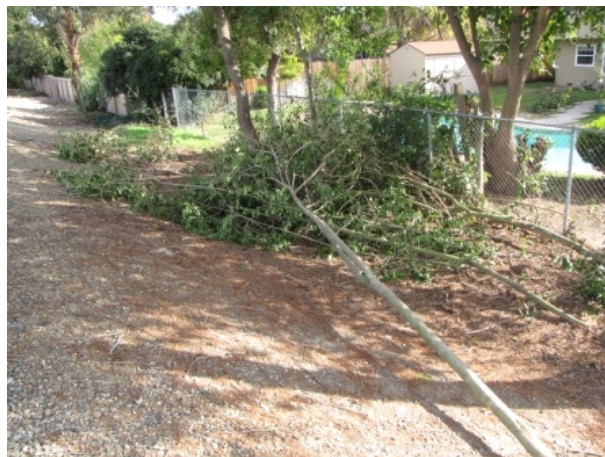
dpesaven_20091124_596.jpg

View of prunings on the landward slope and toe looking upstream.

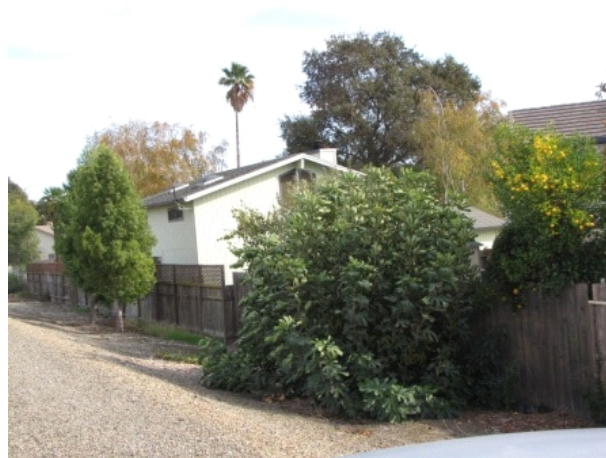
dpesaven_20091124_598.jpg

View of landscaping along the landward slope and toe looking upstream.

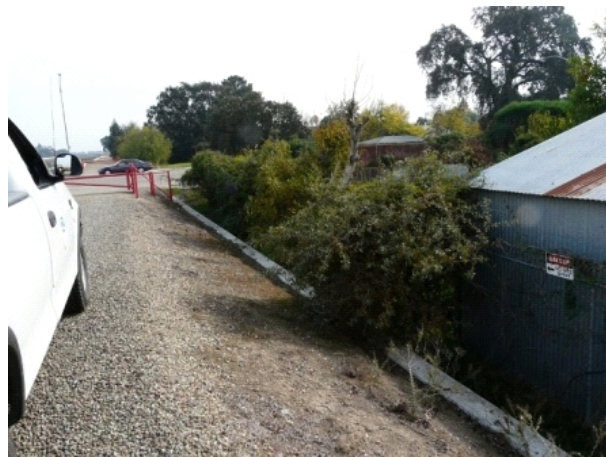
dpesaven_20091022_87.JPG

Landscaping along landside toe of levee from LM 2.87 to LM 2.89

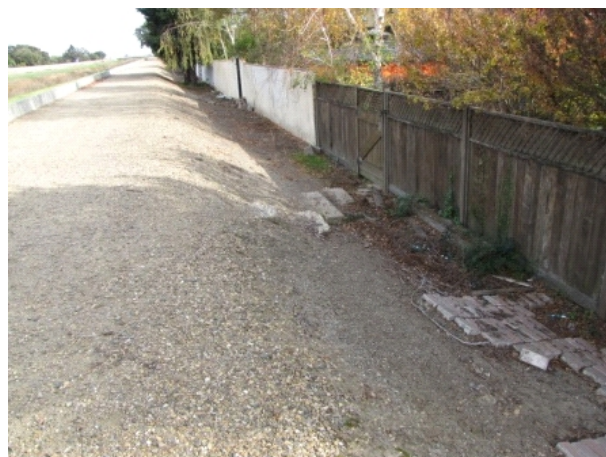
dpesaven_20091124_599.jpg

View of steps dug into the landward slope looking upstream.

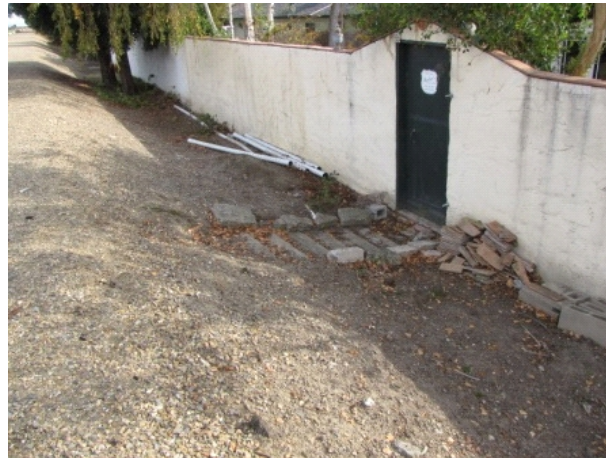
dpesaven_20091124_600.jpg

View of steps dug into the landward slope looking upstream.

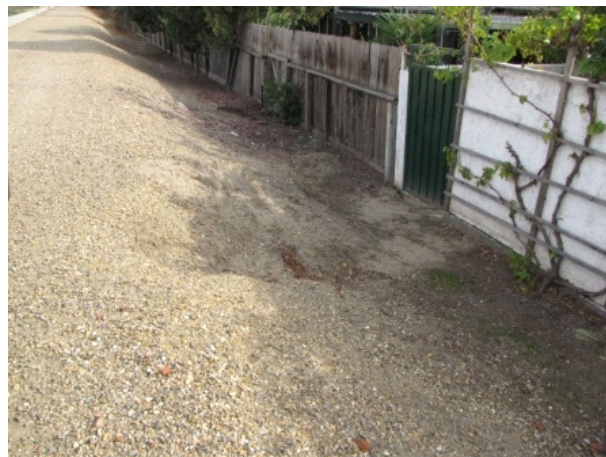
dpesaven_20091124_601.jpg

View of steps dug into the landward slope looking upstream.

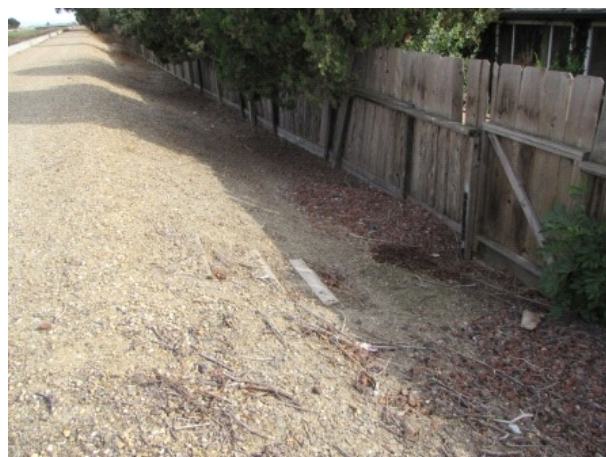
dpesaven_20091124_602.jpg

View of steps dug into the landward slope looking upstream.

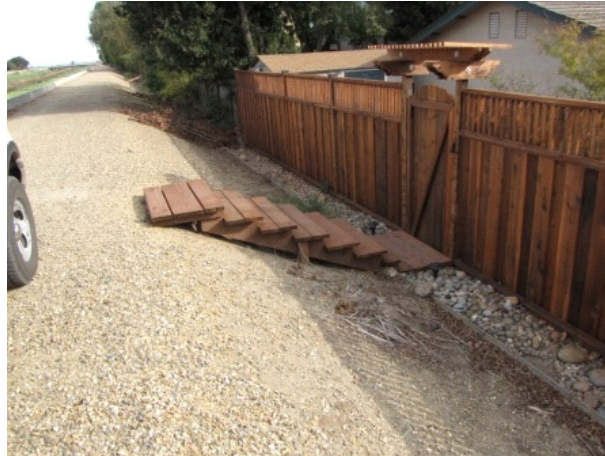
dpesaven_20091124_603.jpg

View of steps dug into the landward slope looking upstream.

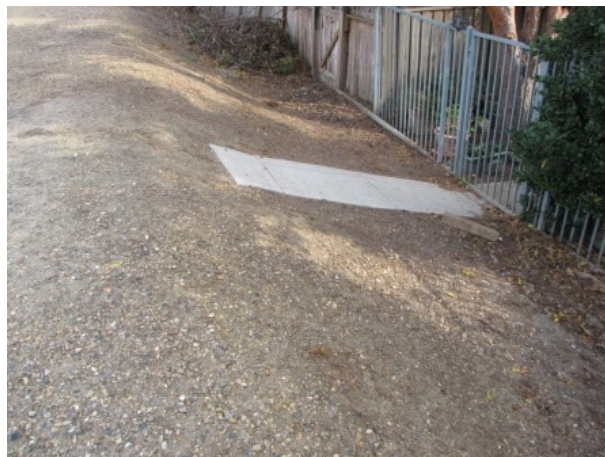
dpesaven_20091124_605.jpg

View of a concrete ramp poured into the landward slope. Some damage caused by foot traffic can be seen at the landward shoulder.

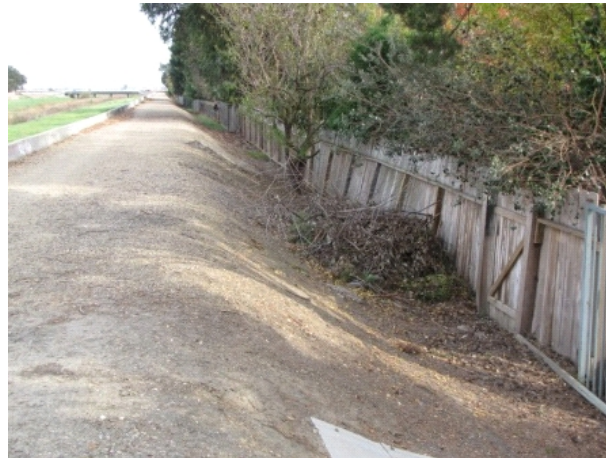
dpesaven_20091124_606.jpg

View of prunings on the landward slope and toe looking upstream.

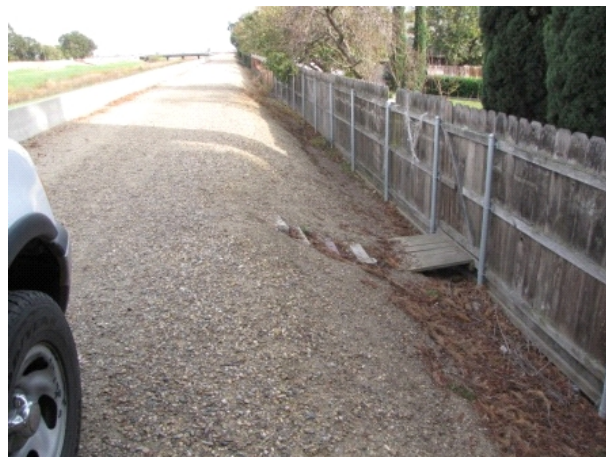
dpesaven_20091124_607.jpg

View of steps dug into the landward slope looking upstream.

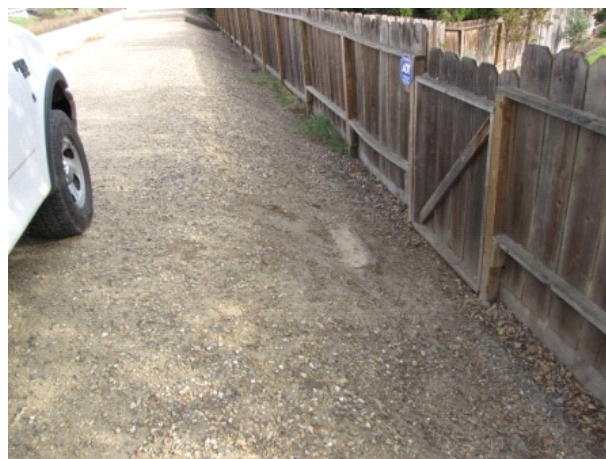
dpesaven_20091124_608.jpg

View of steps dug into the landward slope looking upstream.

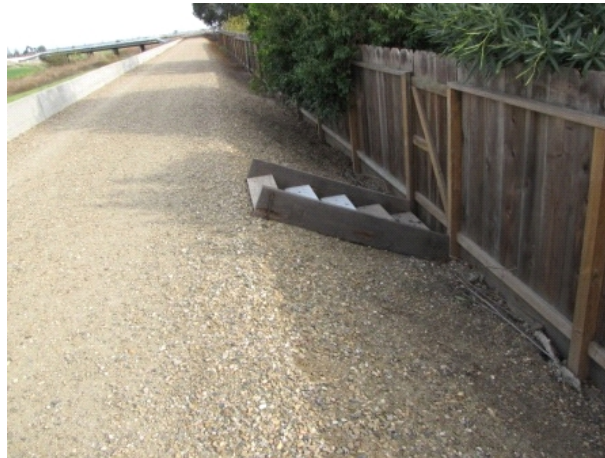
dpesaven_20091124_609.jpg

View of steps dug into the landward slope looking upstream.

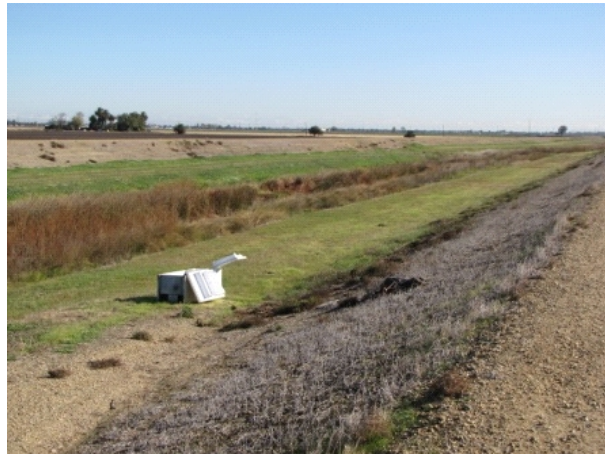
dpesaven_20091124_531.jpg

View of debris at the waterward toe looking upstream.

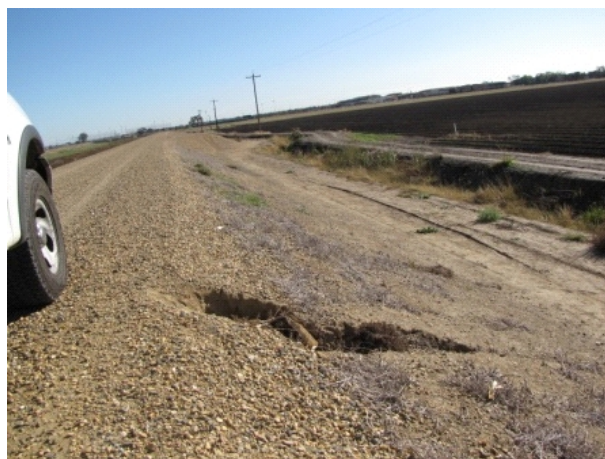
dpesaven_20091124_532.jpg

View of erosion at the landward shoulder looking upstream.

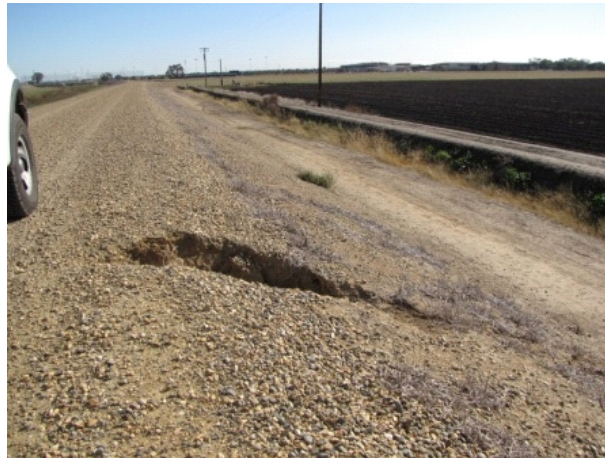
dpesaven_20091124_533.jpg

View of erosion at the landward shoulder looking upstream.

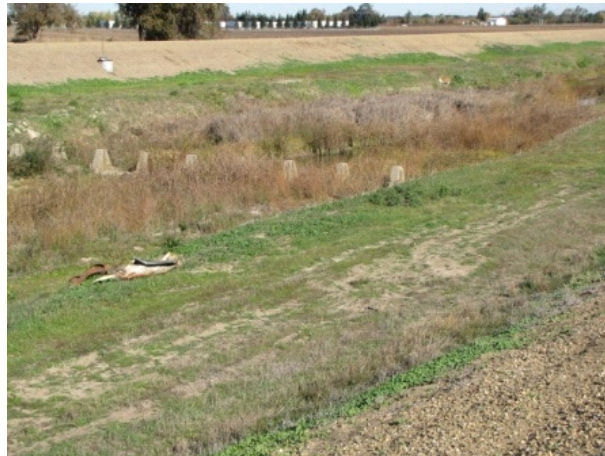
dpesaven_20091124_534.jpg

View of debris on the berm looking upstream.

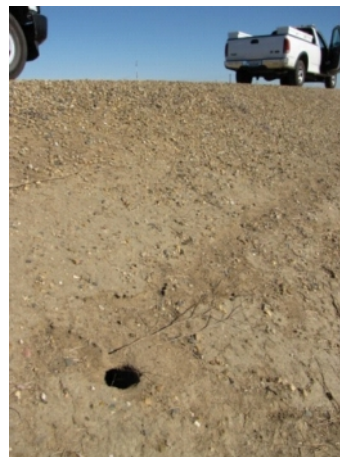
dpesaven_20091124_535.jpg

View of a rodent hole in the landward slope.

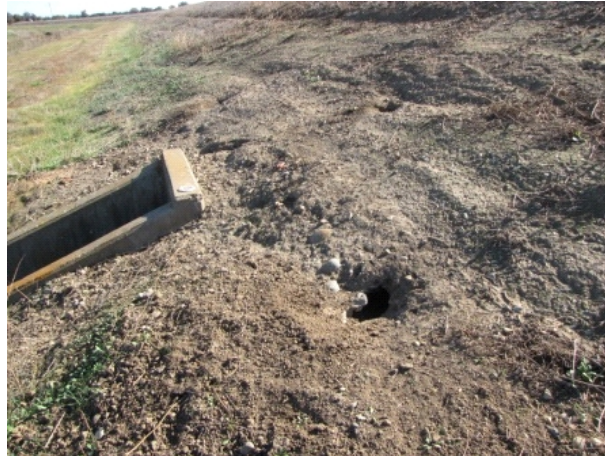
dpesaven_20091124_536.jpg

View of a rodent hole in the waterward slope looking upstream.

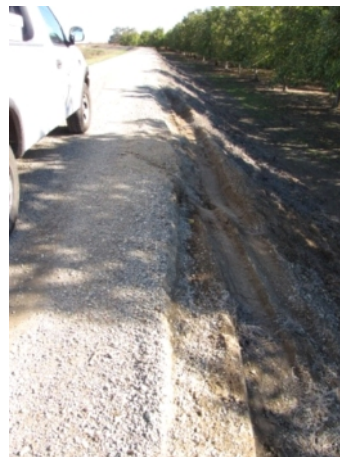
dpesaven_20091124_537.jpg

View of the landward slope damaged by vehicular traffic looking upstream.

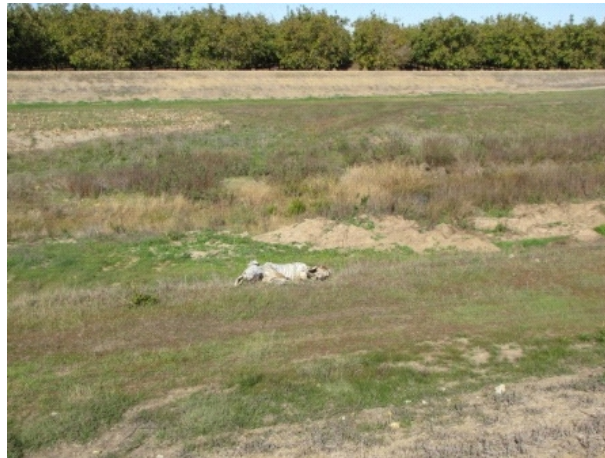
dpesaven_20091124_538.jpg

View of debris on the berm.

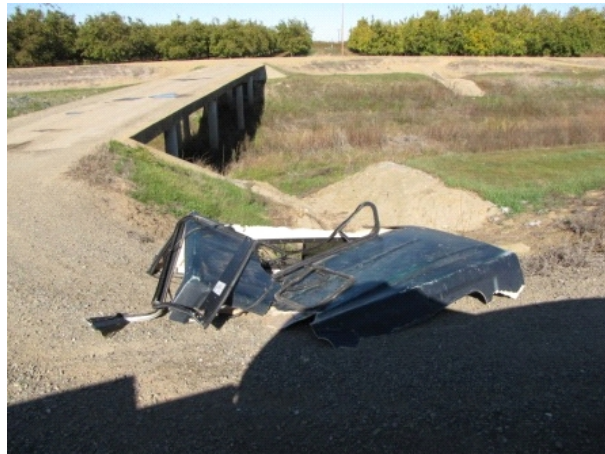
dpesaven_20091124_539.jpg

View of debris on the waterward shoulder.

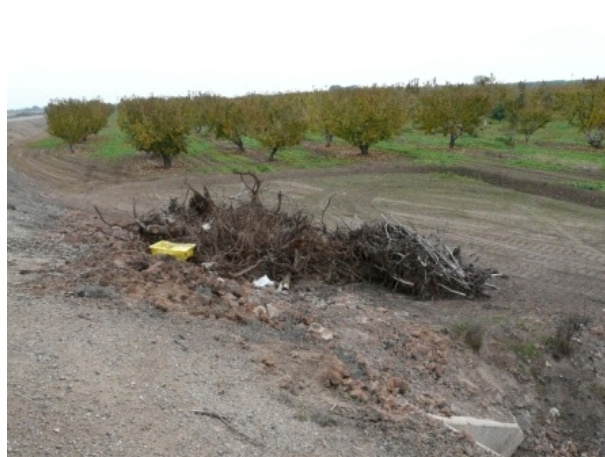
dpesaven_20091022_90.JPG

Levee Mile Report Line	142
Start Levee Mile	9.52
End Levee Mile	9.52
Location	Land Side
Category	Earthen Levee
Item	Encroachments

Remove prunings from landside of levee at LM 9.52

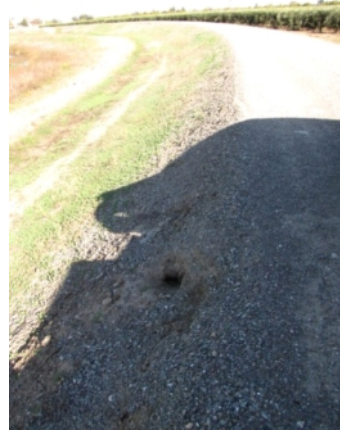
dpesaven_20091124_540.jpg

View of a rodent hole in the waterward slope looking upstream.

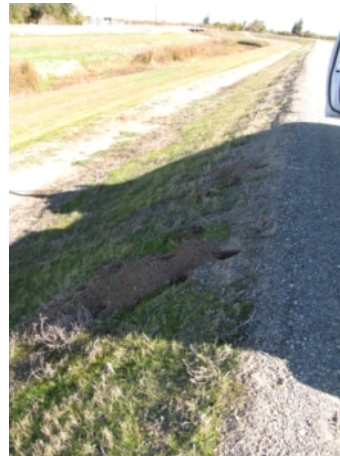
dpesaven_20091124_541.jpg

View of rodent hole in the waterward slope looking upstream.

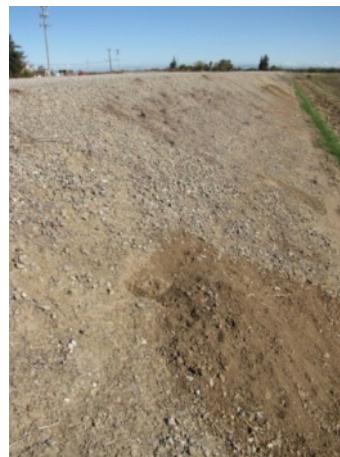
dpesaven_20091124_542.jpg

View of a rodent hole in the landward slope looking upstream.

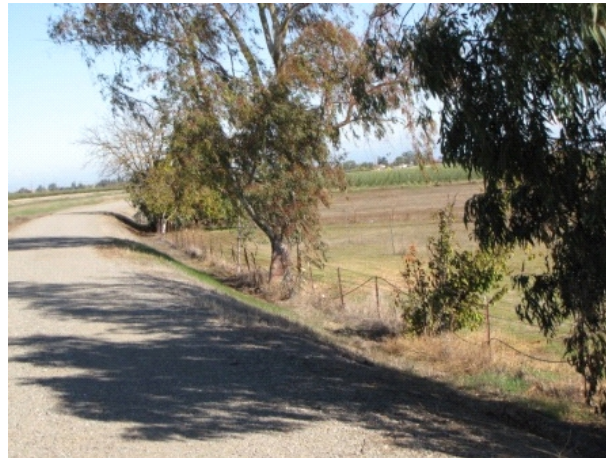
dpesaven_20091124_543.jpg

View of a fence at the landward toe looking upstream.

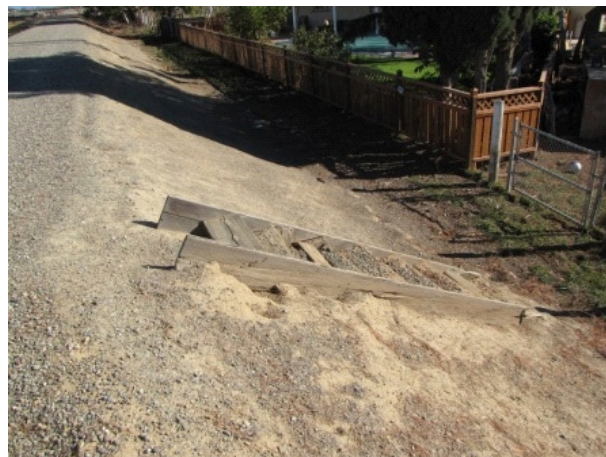
dpesaven_20091124_544.jpg

View of stairs on the landward slope looking upstream.

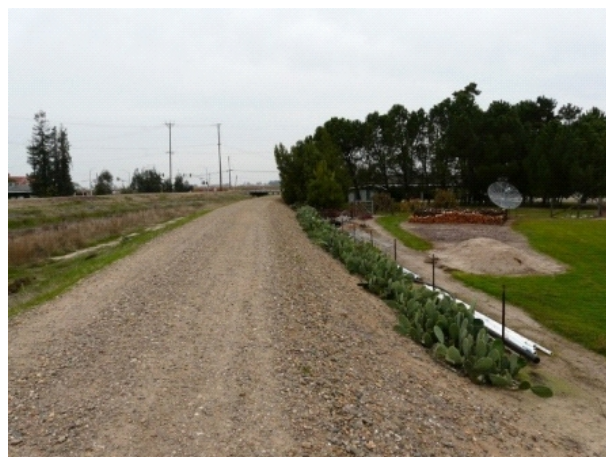
dpesaven_20091022_78.JPG

Levee Mile Report Line	149
Start Levee Mile	13.51
End Levee Mile	13.59
Location	Land Side
Category	Earthen Levee
Item	Encroachments

Landscaping along landside of levee from LM 13.51 to LM 13.59. Trim trees along landside of levee slope to allow for visibility from LM 13.54 to 13.59.

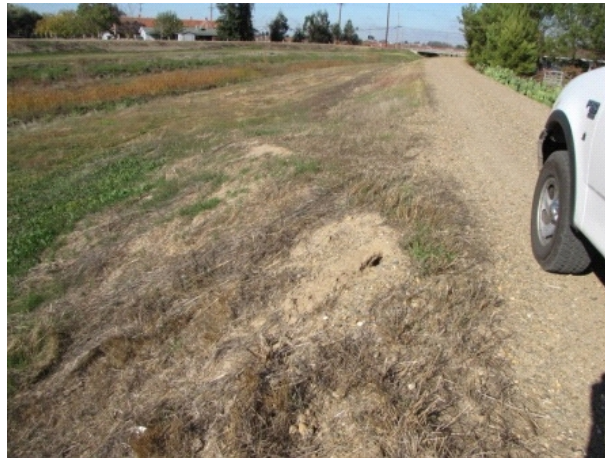
dpesaven_20091124_509.jpg

View of rodent hole in waterward slope looking upstream.

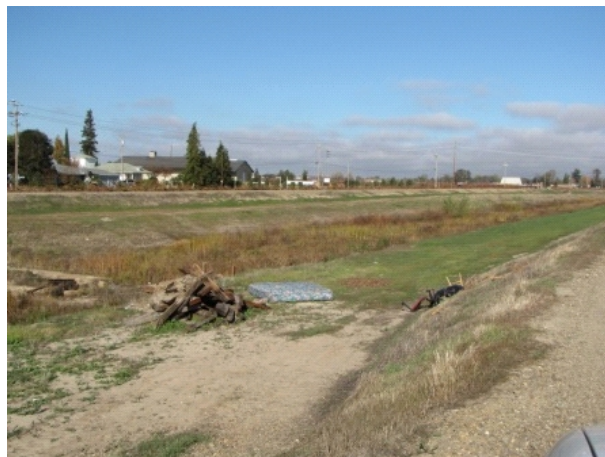
dpesaven_20091124_510.jpg

View of debris on waterward slope and berm looking upstream. Some of this debris is from the flapboard dam but must be removed from the floodway during flood season.

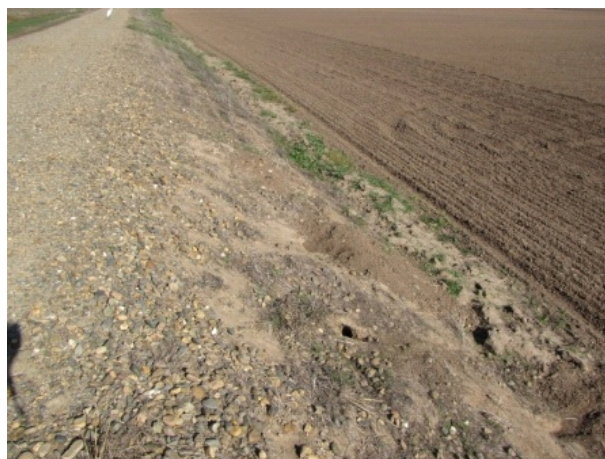
dpesaven_20091124_511.jpg

View of rodent activity on landward slope looking upstream.

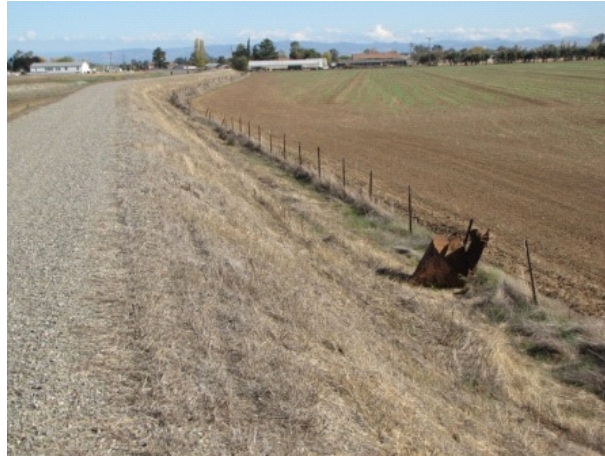
dpesaven_20091119_487.jpg

View of debris at the landward toe looking upstream.

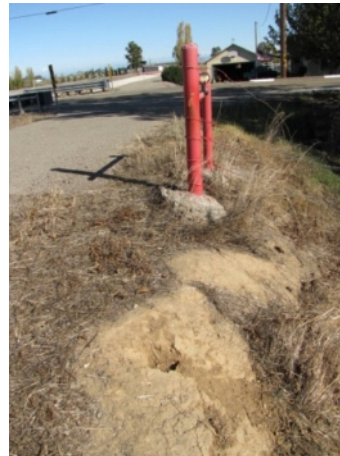
dpesaven_20091119_488.jpg

View of rodent activity at the landward shoulder looking upstream.

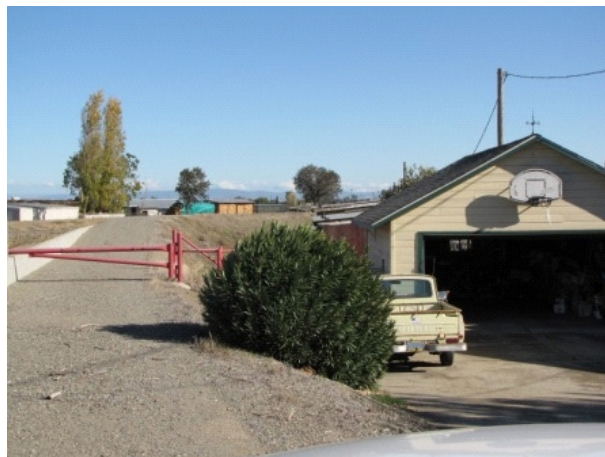
dpesaven_20091119_489.jpg

View of an oleander bush maintained by the landowner obstructing visibility and access looking upstream.

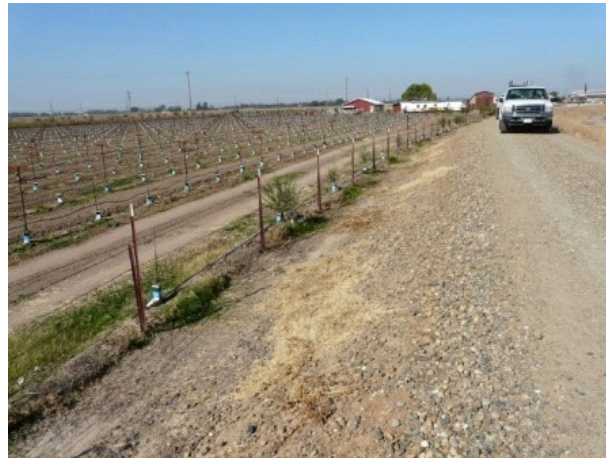
dpesaven_20091002_34.JPG

Fence located from LM 0.17 to LM 0.49 and crops located from LM 0.17 to LM 0.41 within 10' from landside toe of levee.

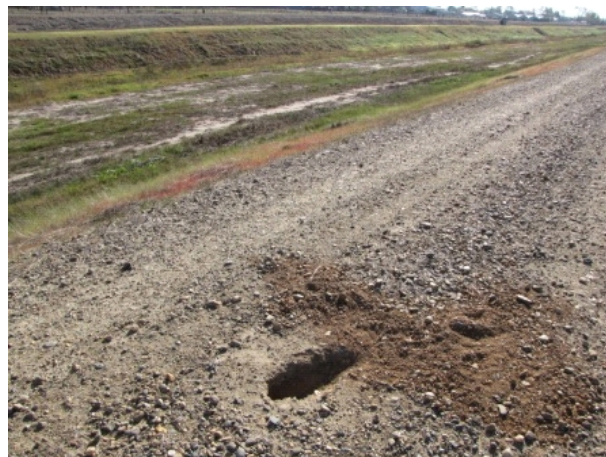
dpesaven_20091124_524.jpg

View of rodent holes in the crown looking downstream.

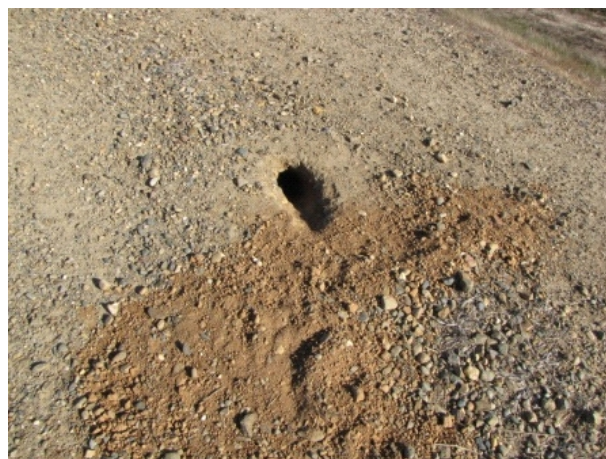
dpesaven_20091124_525.jpg

View of rodent holes in the landward slope.

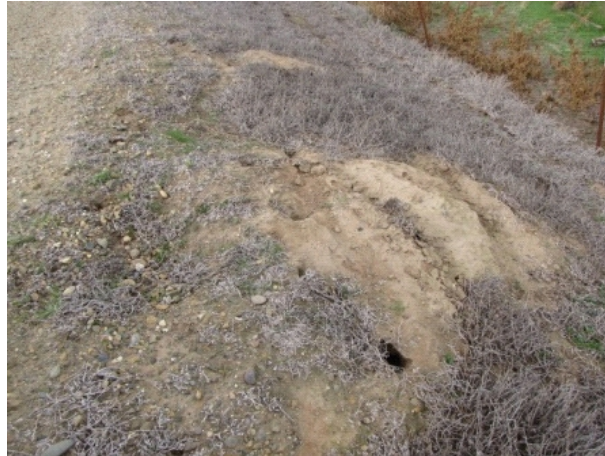
dpesaven_20091124_522.jpg

View of rodent holes in the landward slope looking downstream.

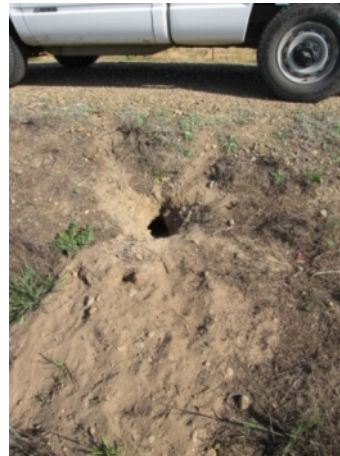
dpesaven_20091002_36.jpg

Levee Mile Report Line	8
Start Levee Mile	3.09
End Levee Mile	3.09
Location	Water Side
Category	Earthen Levee
Item	Animal Control

Exterminate the rodents and backfill and compact all rodent holes.

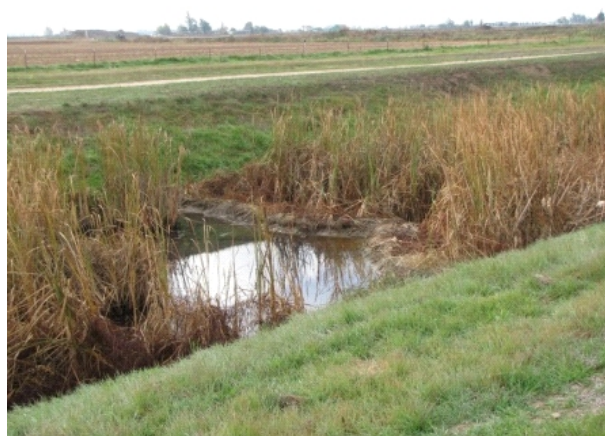
dpesaven_20091124_521.jpg

View of an earthen dam in the channel looking downstream.

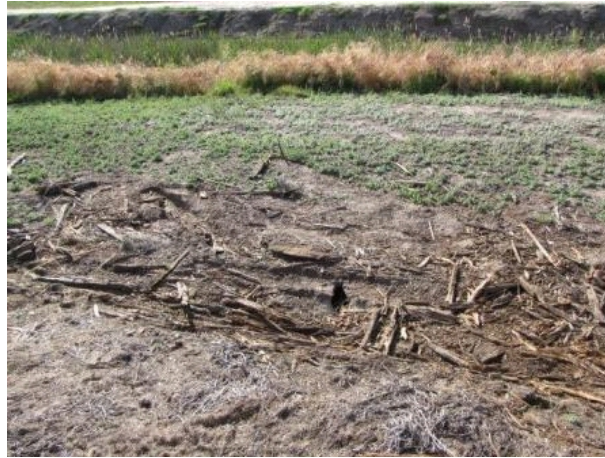
dpesaven_20091002_35.jpg

The debris pile previously noted has been removed, but there are rodent holes under the pile. Backfill and compact the rodent holes.

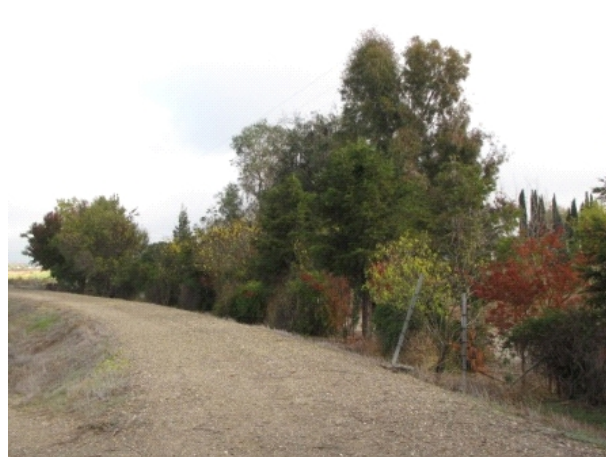
dpesaven_20091124_512.jpg

Updated view of landscaping as of fall 2009. The county has removed as much of the vegetation on the creek side of the fence as they can at this time.

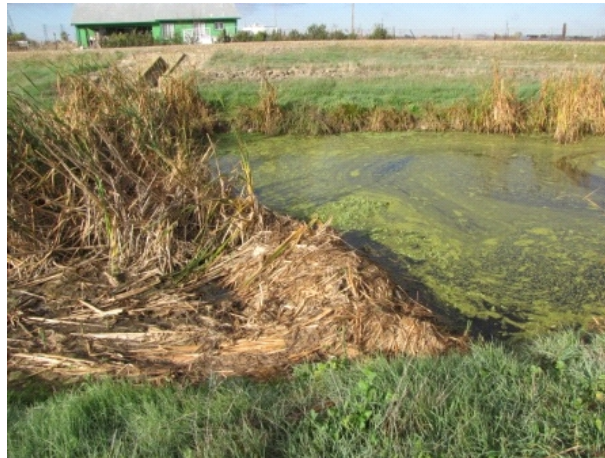
dpesaven_20091124_513.jpg

View from downstream of earthen dam in channel.
